| CONSULTANT | CSR Consultant & Associates |
| Society Name | Rooftop CHSL, Andheri (E) |

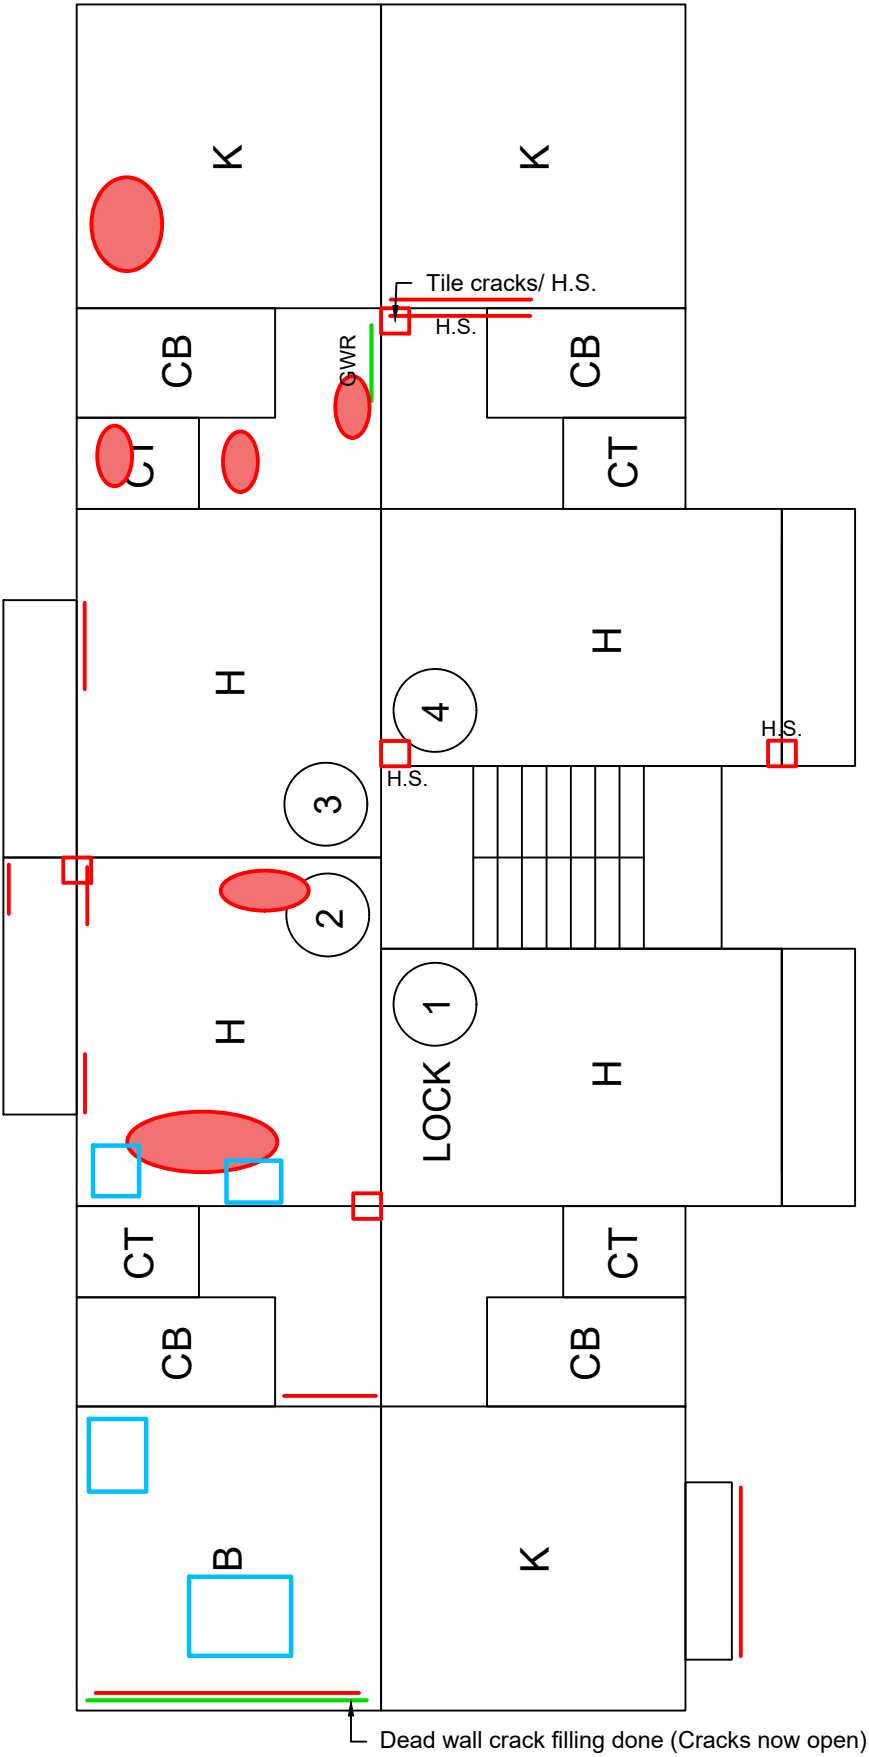
Dead wall crack filling done (Cracks now open)

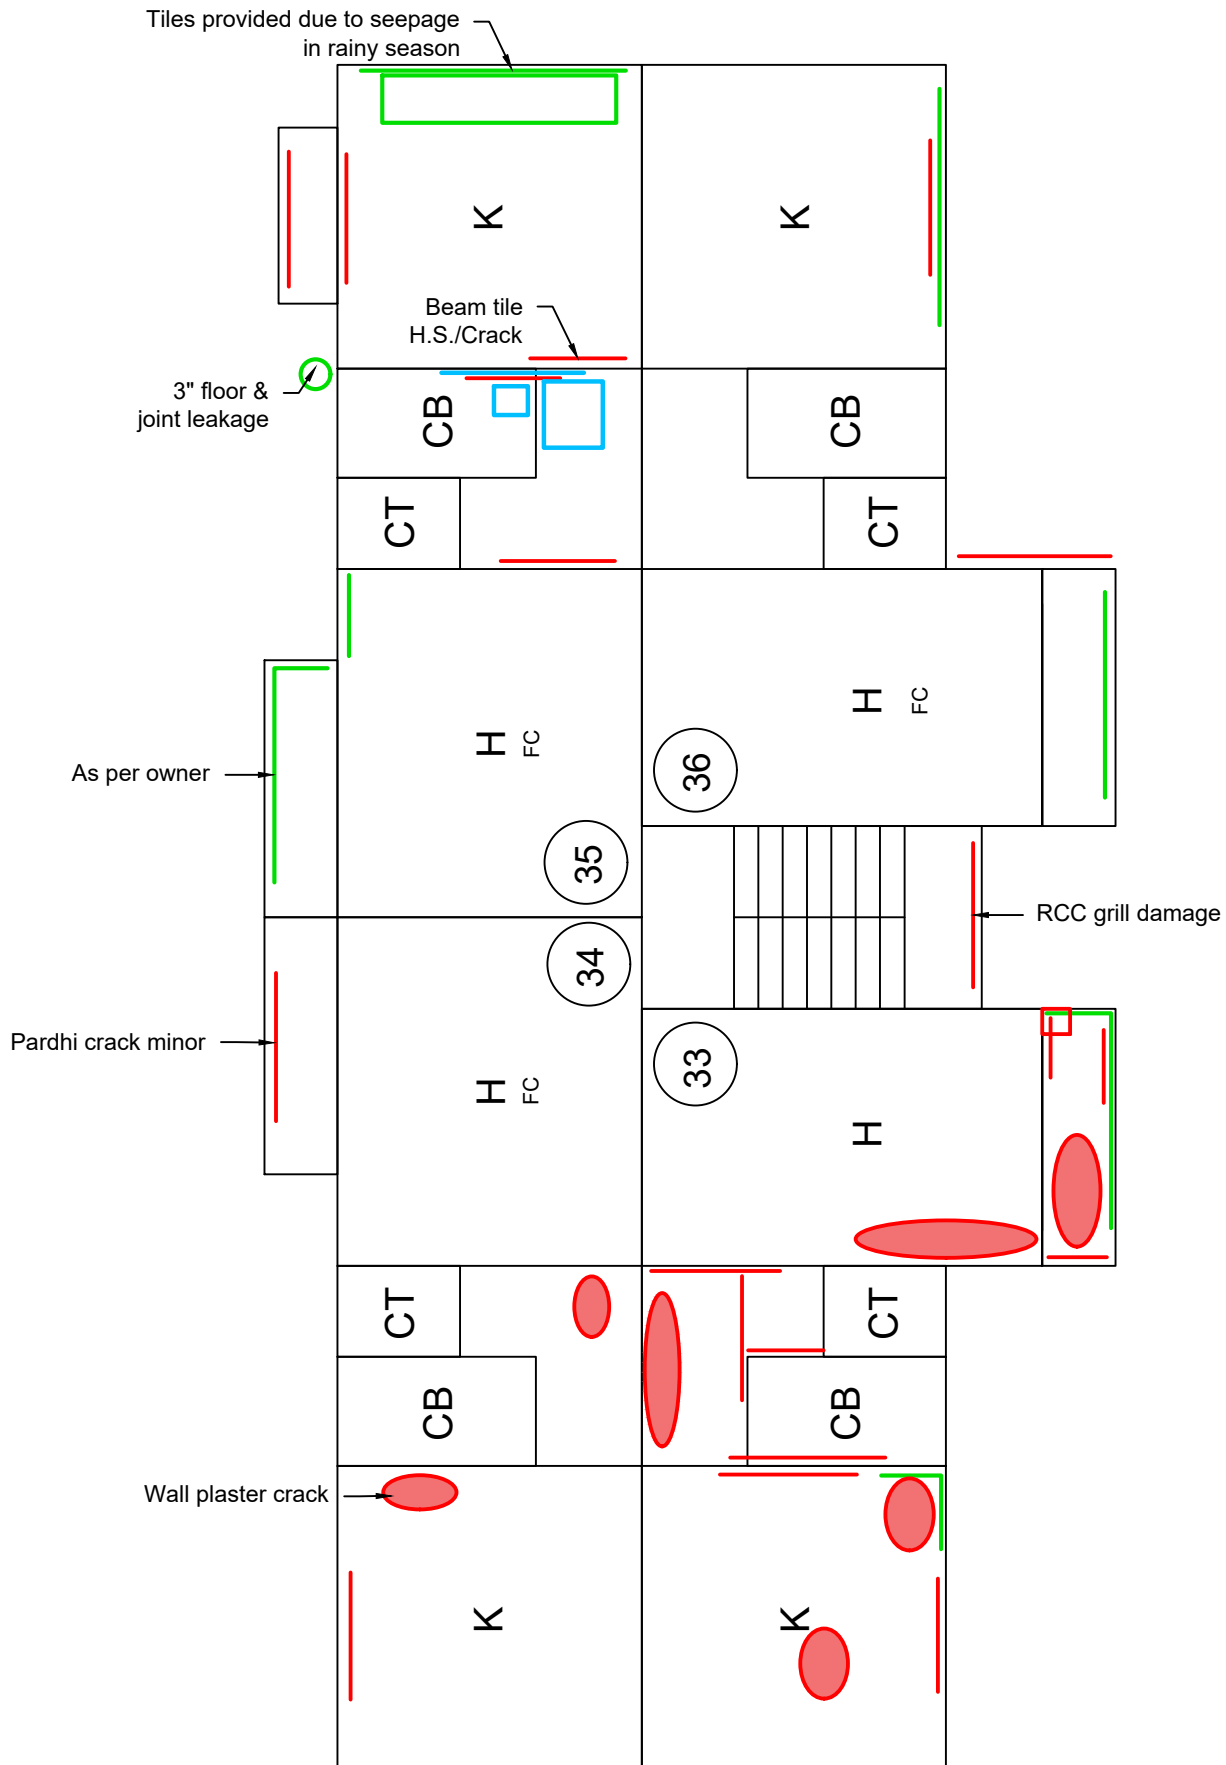
Tiles provided due to seepage in rainy season
